CHARACTERIZATION OF ELECTRICALLY ACTIVE
DEFECTS IN SI USING CCD IMAGE SENSORS

H. F. Schaake
C. G. Roberts
A. J. Lewis

Texas Instruments Incorporated

Quarterly Technical Report
1 September 1977 - 30 November 1977

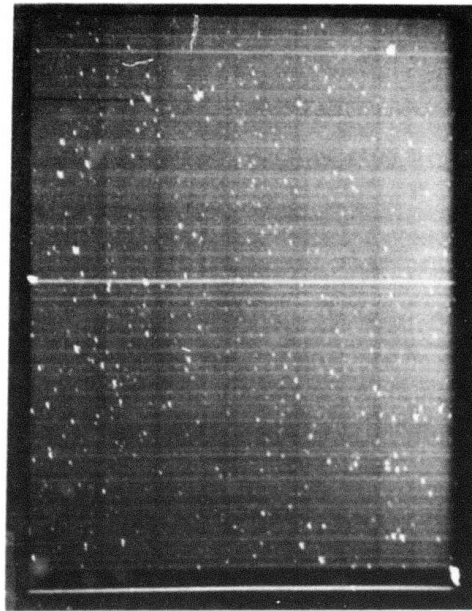
A typical dark current pattern observed in devices made on this material is shown in Figure 1. The random distribution of dark current spikes illustrated in this figure is typical of all imagers that were operated on the slice.

Figure 1 Dark Current Patterns: Czochralski - Control Group

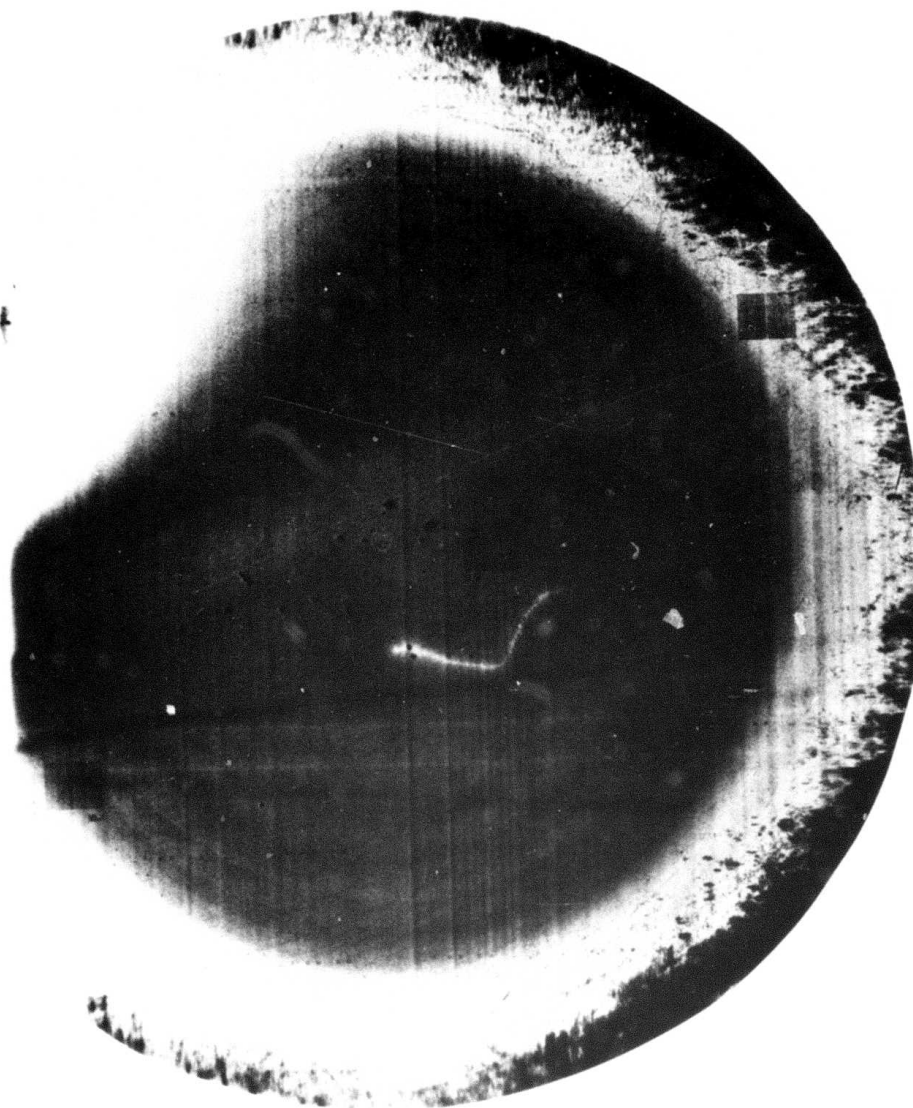
Very few defects were imaged in both reflection and transmission x-ray topography. Consequently, there is no correlation between the predominant dark current producing defect and defects visible in x-ray topography. However, transmission topography showed that the bulk of the slice contained a uniform "swirl" precipitate (Figure 2).

Figure 2 (220) Transmission Topograph of Wafer from Czochralski - Control Group.
Note bulk swirl precipitation region covering most of the slice.

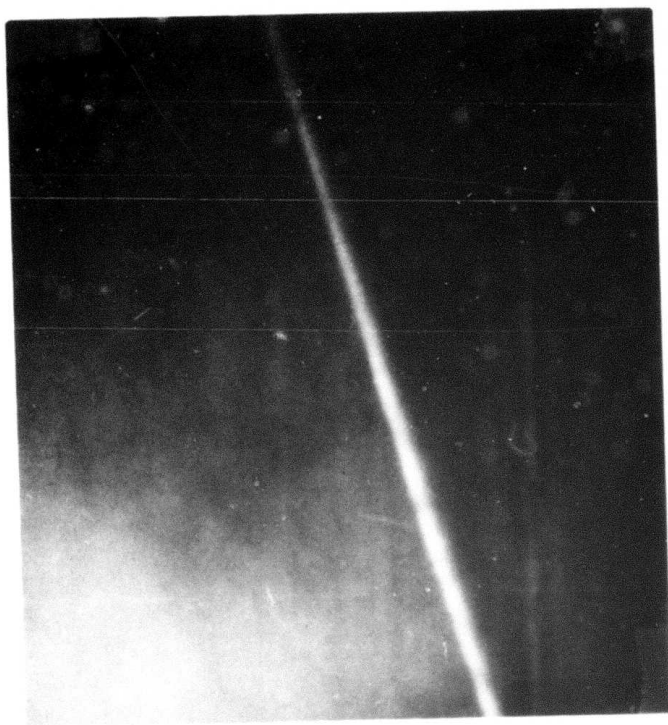
Figure 5 Weak Beam (400) Micrograph of Pure Edge Dislocation in Czochralski - Control Group. The dislocation is not dissociated.

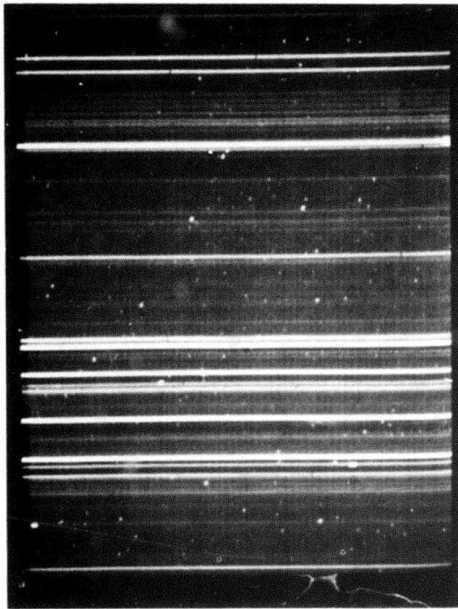
Dark current patterns from imagers on float-zoned material fell into two distinct categories. Devices in the central region of one slice and about the periphery of all slices showed dense patches of dark current lines running in $\langle 110 \rangle$ directions on the slice [Figure 6(a)]. Devices outside of these regions showed a moderately low density of randomly distributed isolated dark current spikes [Figure 6(b)].

Figure 6 Dark Current Patterns - Float-Zoned Group

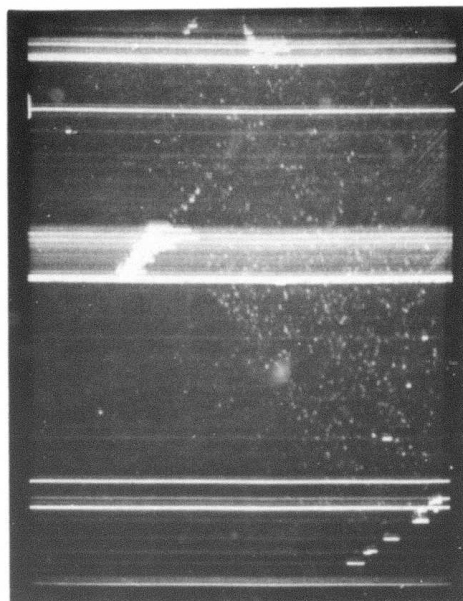
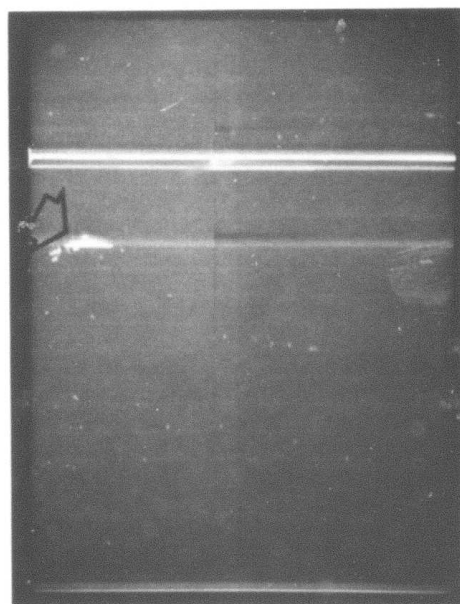
The dark current spike behavior of this material was similar to that of Czochralski - Group 1. Imagers at the periphery of the slice had a moderately high density of weak dark current spikes, many of which were in a discernible pattern (Figure 16), while those near the center of the slice had a relatively low density of dark current spikes. Backside mechanical damage by glass bead sandblasting had no discernible effect on the dark current spikes.

Figure 16 Dark Current Patterns of Three Adjacent Devices, Czochralski Group 2
Defect at arrow in device 3 is shown in topograph, Figure 17.

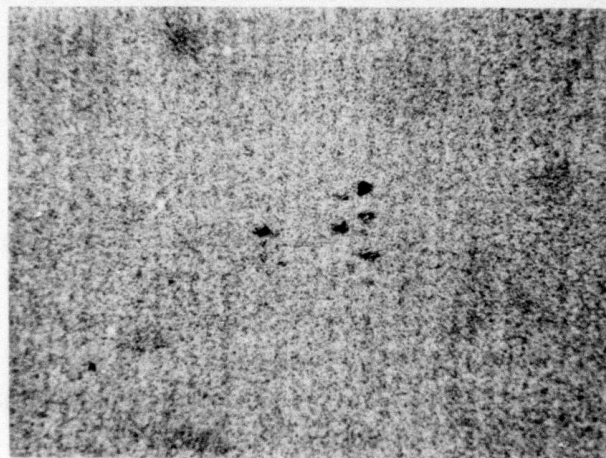
Only a few defects were imaged in reflection topography. These defects correlated with the more intense dark current spikes near the center of the slice. A typical example is shown in Figure 17, which correlates with the indicated dark current defect in device 3 of Figure 16. From the pattern of dark current defects of this type that were visible in the imagers and the topographs, it appears that their origin is frontside damage caused by handling of the slice before processing. (The backside damage was applied after the completion of the frontside polish.) No defects were imaged in reflection topography that correlated with the moderate number of dark current defects visible in some of the imagers.

Figure 17 224 Reflection Topograph of Dark Current Defects in Czochralski Group 2. Defect is marked in Figure 16, device 3.

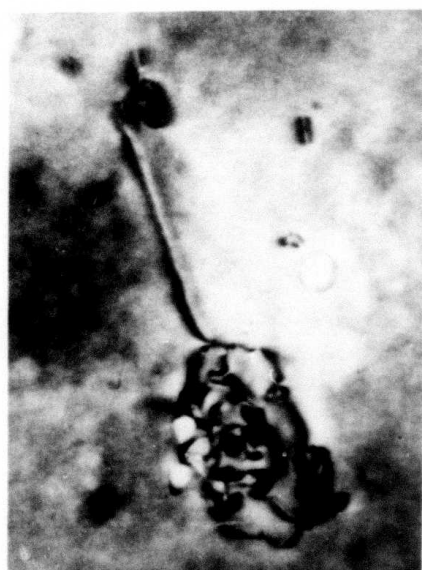
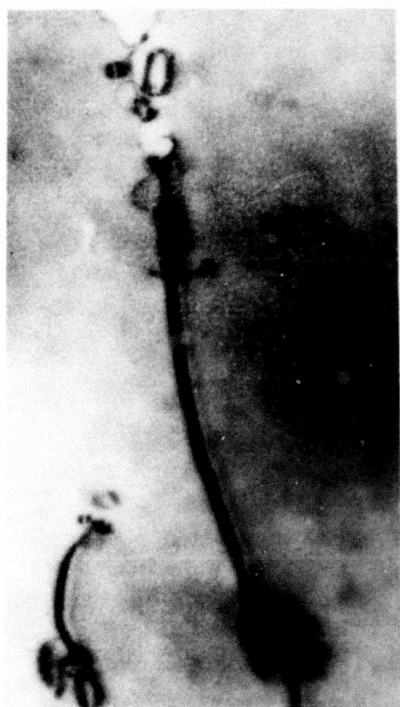
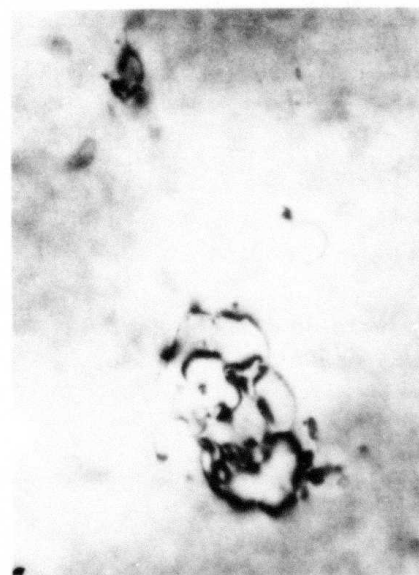
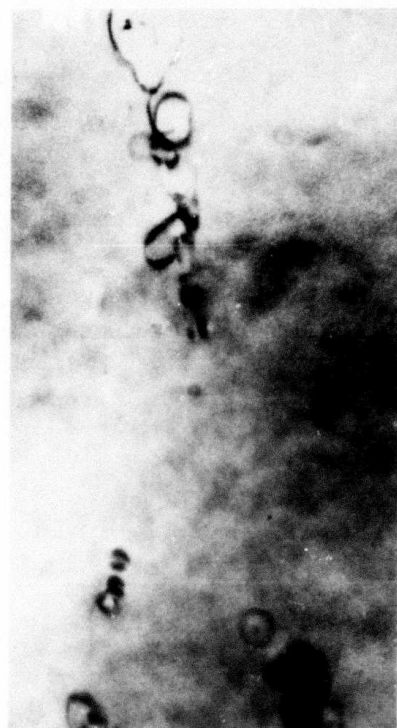
Samples taken from high defect regions of other devices had the dislocation clusters shown in Figure 20. Limited contrast experiments in the electron microscope showed that the long dislocation line in these clusters, which was oriented in a $\langle 110 \rangle$ direction, was of pure edge type. All these dislocation clusters were located in the channel stop.

The defects that were imaged (Figure 20) appear to have originated from a stacking fault.

Figure 20 Dislocation Clusters in Channel Stop Region. The longer dislocation lines are pure edge.

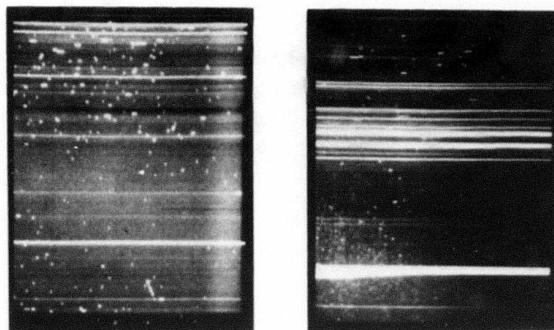
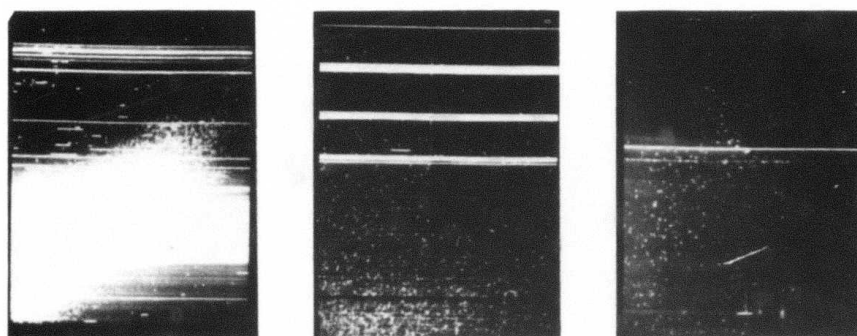
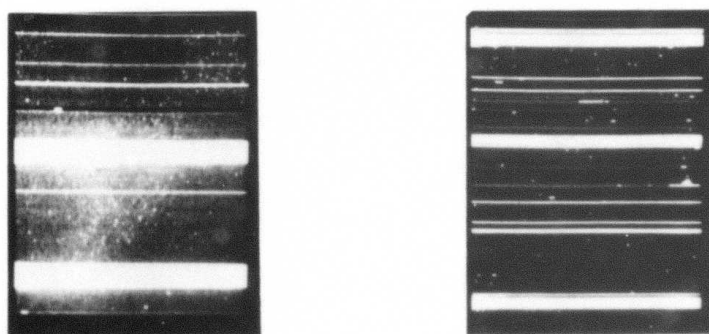
Figure 24 Dark Current Readout of Typical Devices from Slices Treated with the ISS Backside Damage
